ID No. 3KP-BL7-RS-I-3-202310 Version No. 01

1. Identification / recognition

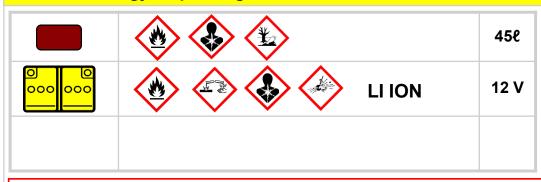
5. Stored energy / liquids / gases / solids

550 ± 25g
